Manhole Inspection Summary

Manhole # S47II_046MH

Insp Date: **5/1/08 9:54 AM**

Location Address: **Oliver St**

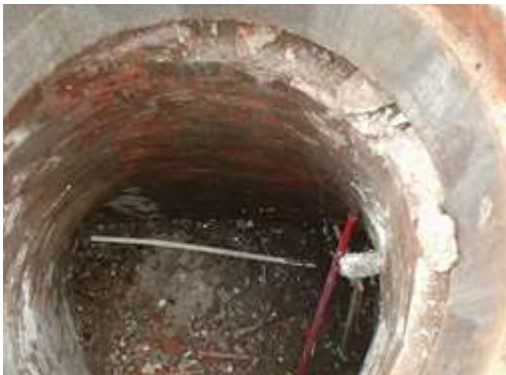
Defect 1

Deterioration

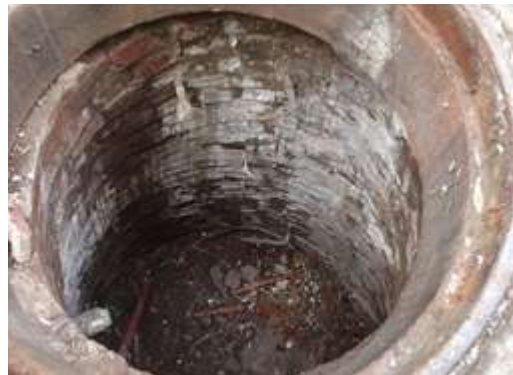
Defect 2

Condition: ☐ Sound ☐ Cracked ☐ Root Intrusion ☒ **Loose Brick** ☐ Deteriorated

Infiltration: ☐ None ☒ **Joint** ☐ Cracks ☒ **Mortar** ☐ Roots ☐ Wall

Loose Bricks

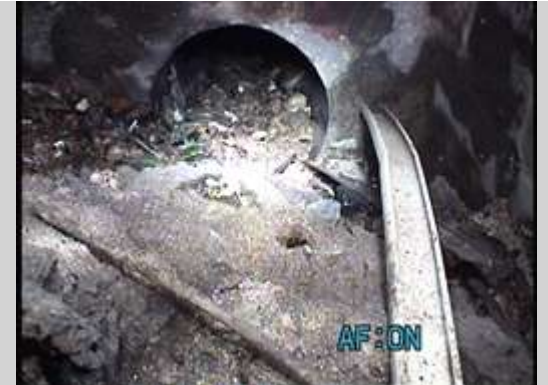
12 O'Clock Outflow

8 in. Circular Gravity Sewer
Pipe Out @ 12 O'Clock

Deposits: ☐ None ☐ Mud ☐ Sludge ☒ **Debris** ☐ Grease

Silt Depth: **4** (in.) Deposits Extent: **Medium**
